Design And As-Built Geotechnical Report For Emergency Stabilization

5700 Block Desert View Drive Alley, La Jolla, California

Prepared for
City of San Diego

October 14, 2010

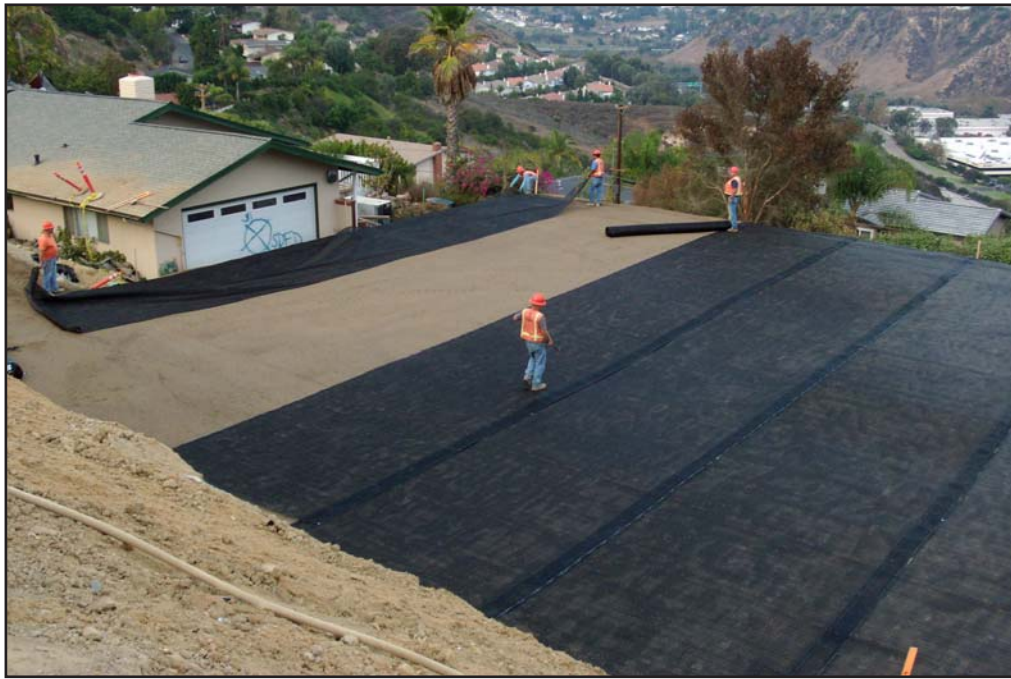
INSTALLATION OF GEOGRID DURING CONSTRUCTION OF CRANE PAD

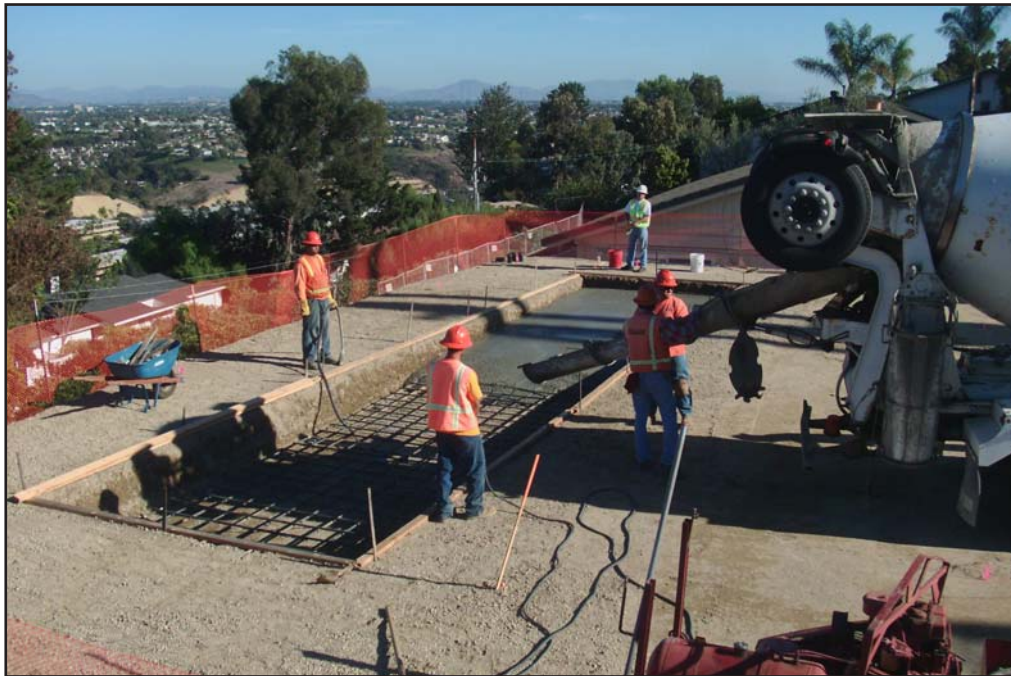
CONSTRUCTION OF 24-INCH THICK MAT FOUNDATION FOR CRANE OUTRIGGER SUPPORT

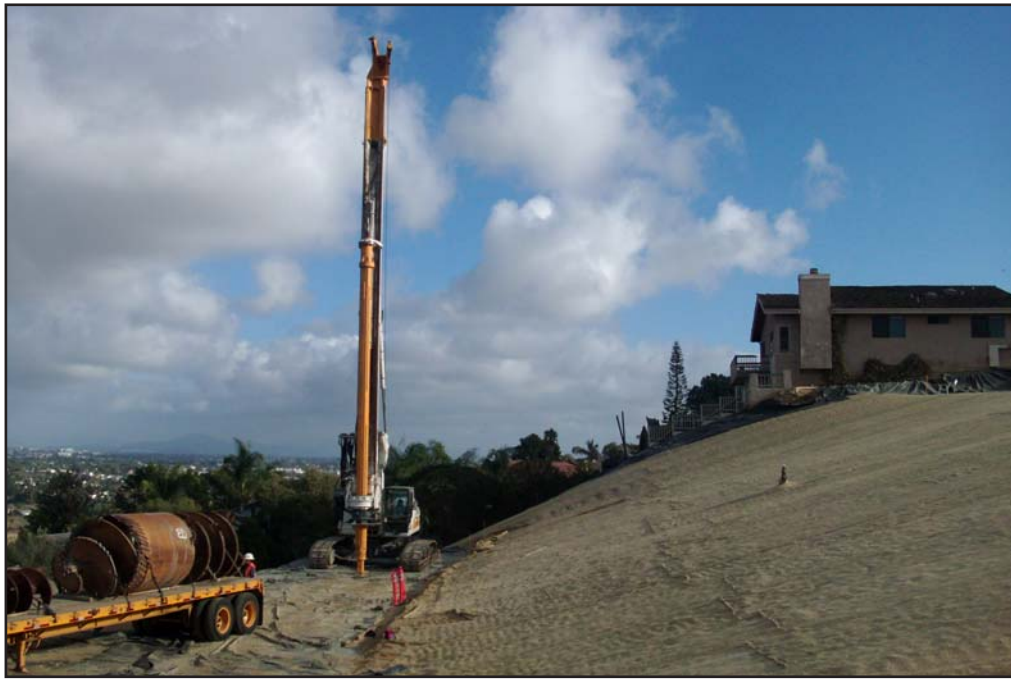
SHEAR PIN DRILLING ON TEMPORARY DRILLING BENCH AT ELEVATION 440'

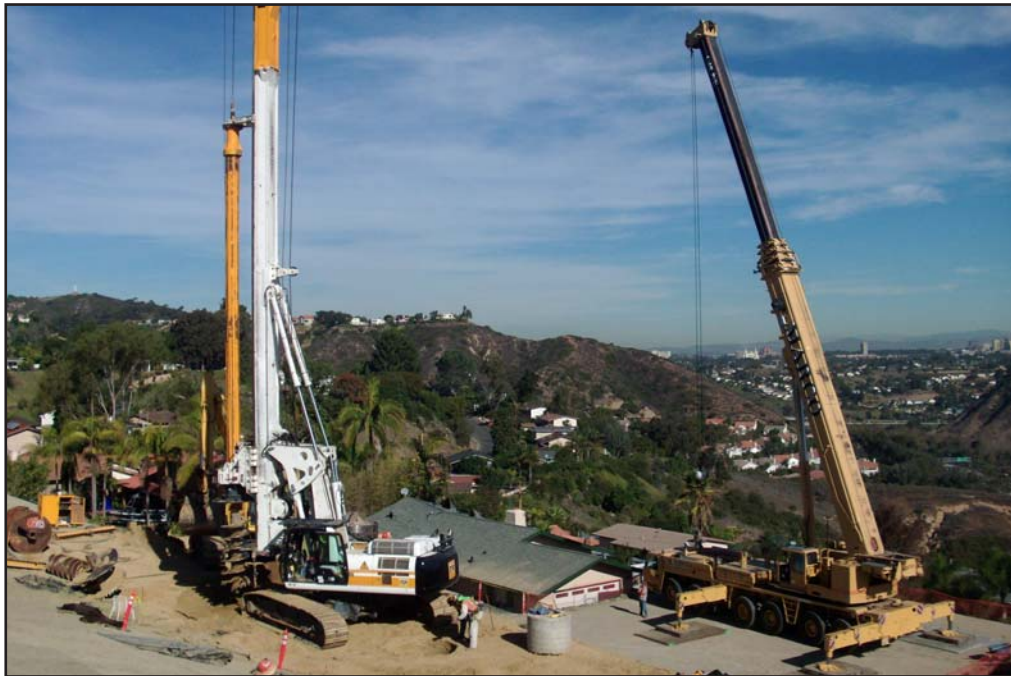
DRILLING AND HEAVY LIFTING EQUIPMENT SETUP DURING SHEAR PIN INSTALLATION

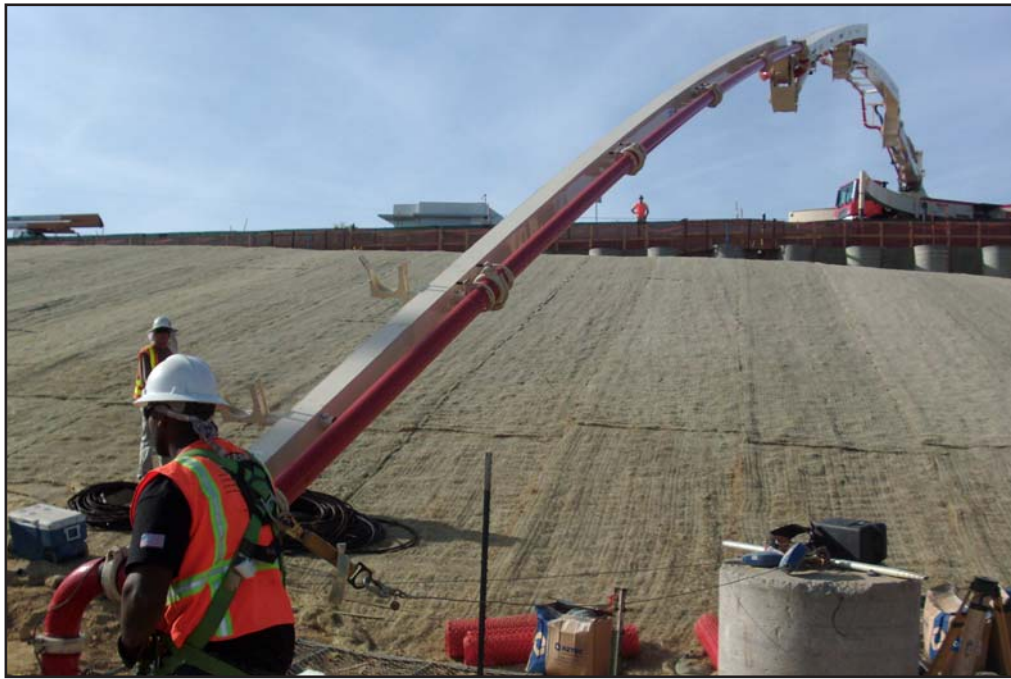
PUMPING CONCRETE FOR CIDH SHEAR PIN VIA BOOM TRUCK ON SOLEDAD MOUNTAIN ROAD

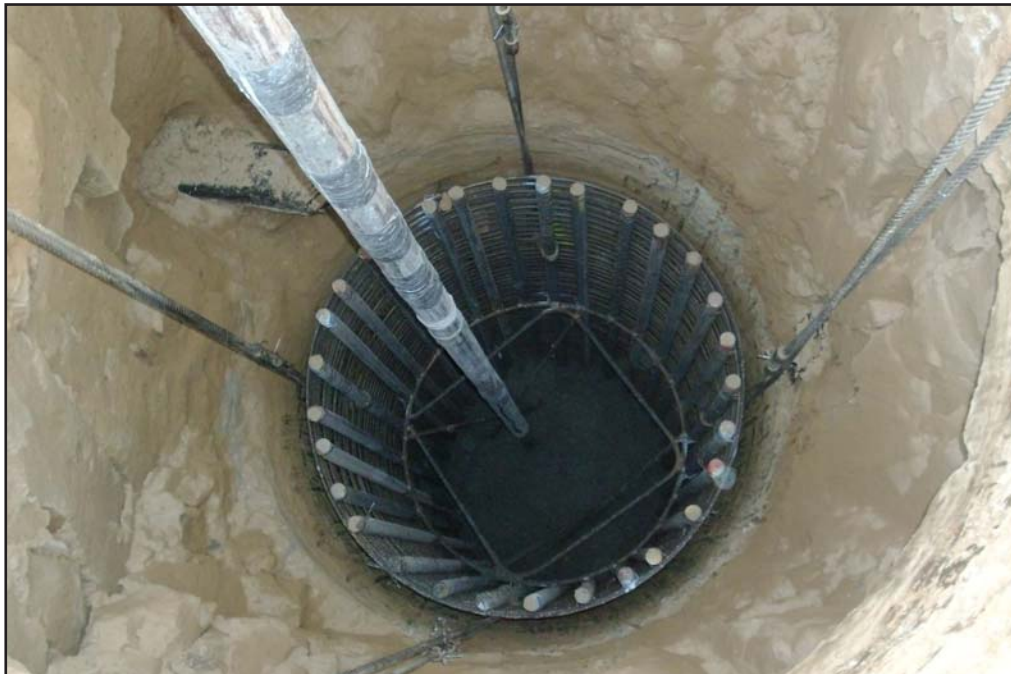
CONCRETE PLACEMENT INSIDE REINFORCEMENT CAGE VIA TREMIE METHOD

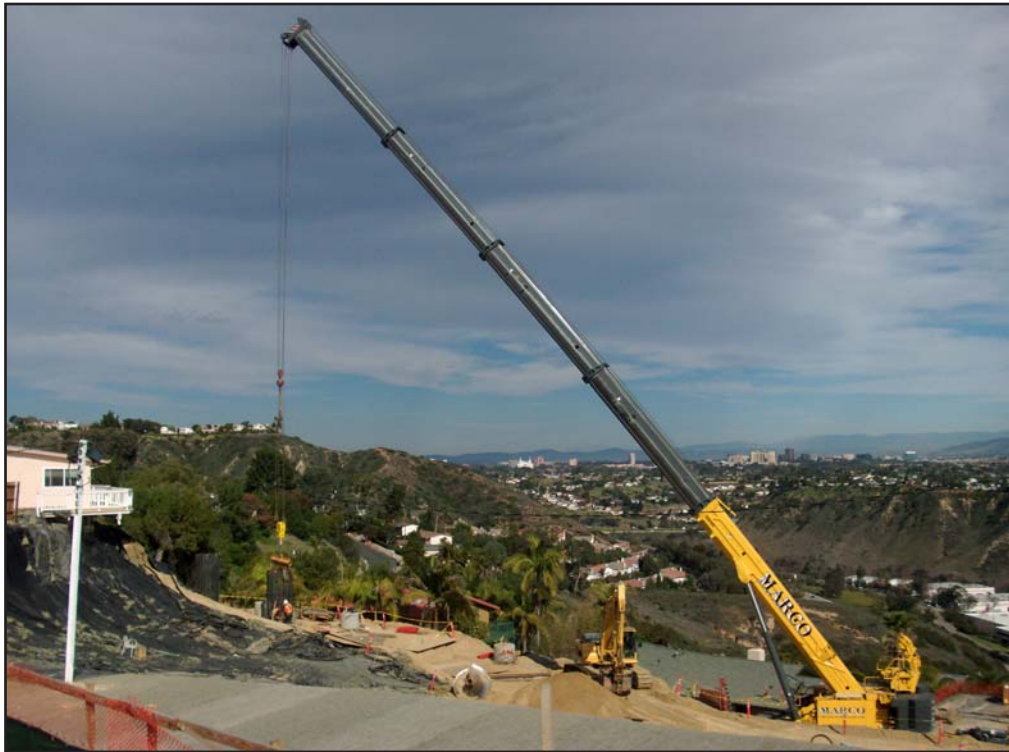
LIFTING OF REINFORCEMENT CAGE

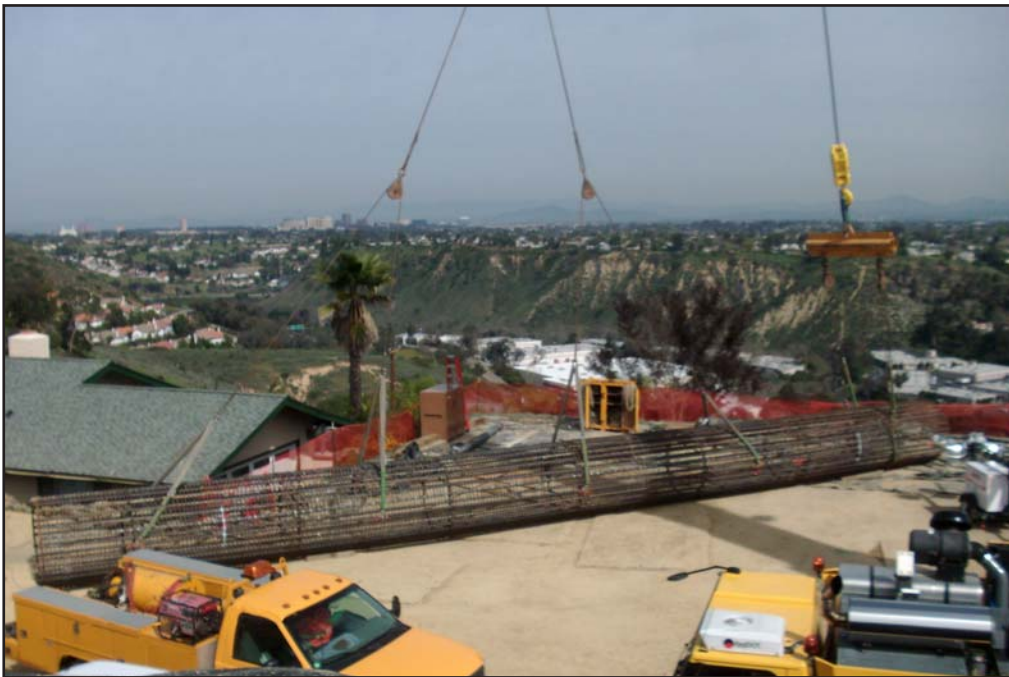
RIGGING SETUP FOR LIFTING OF REINFORCEMENT CAGE

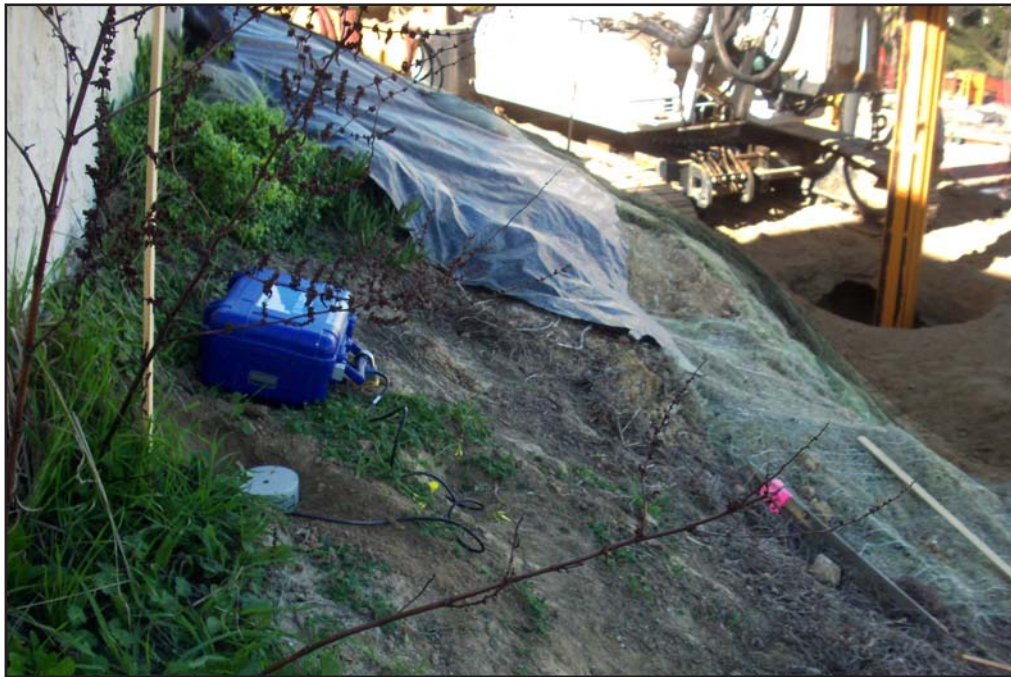
VIBRATION MONITORING DURING DRILLING OPERATIONS

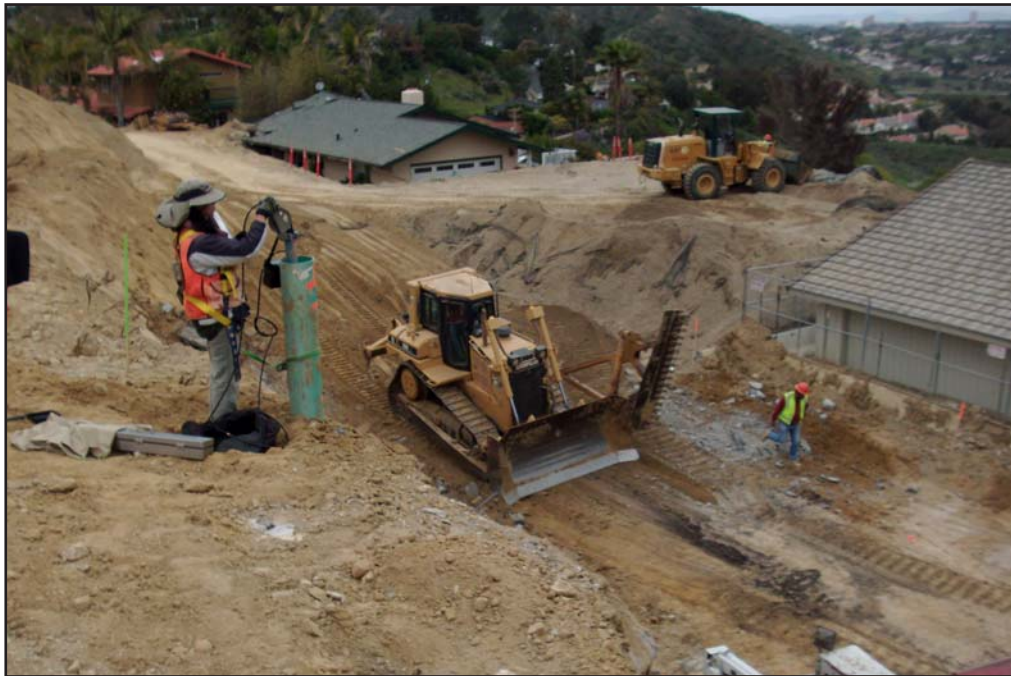
INCLINOMETER MONITORING DURING EXCAVATION OF SLOT 3

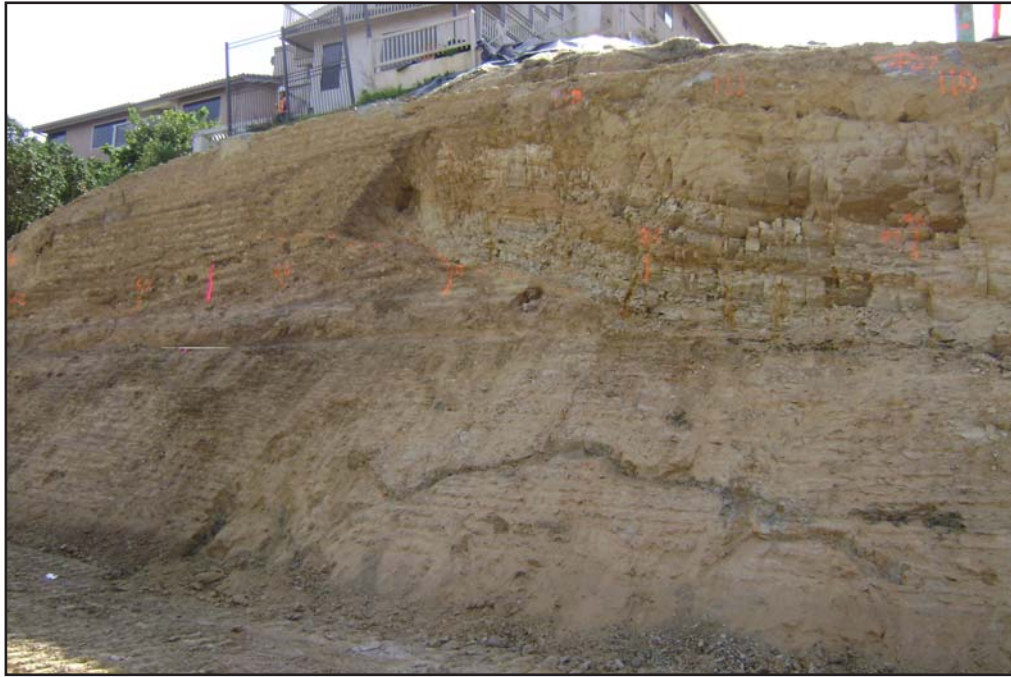
SLOT 3 BACKCUT

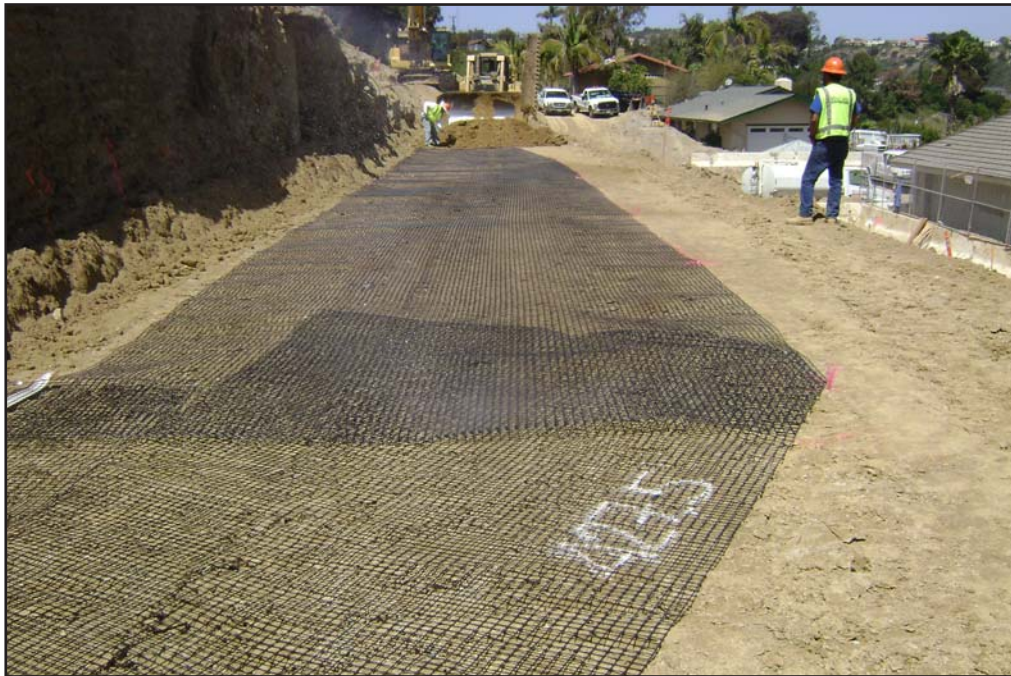
GEOGRID PLACEMENT AT ELEVATION 427.5' DURING CONSTRUCTION OF 1.5:1 (H : V) SLOPE ABOVE SLOT 3

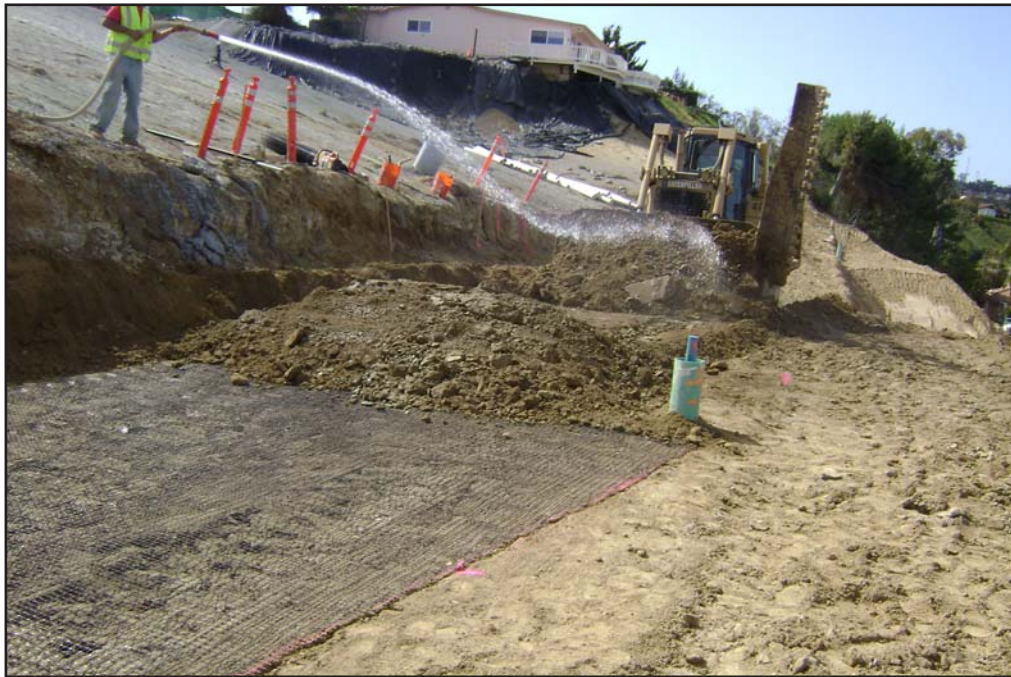
PLACEMENT OF FILL ON TOP OF GEOGRID LAYER

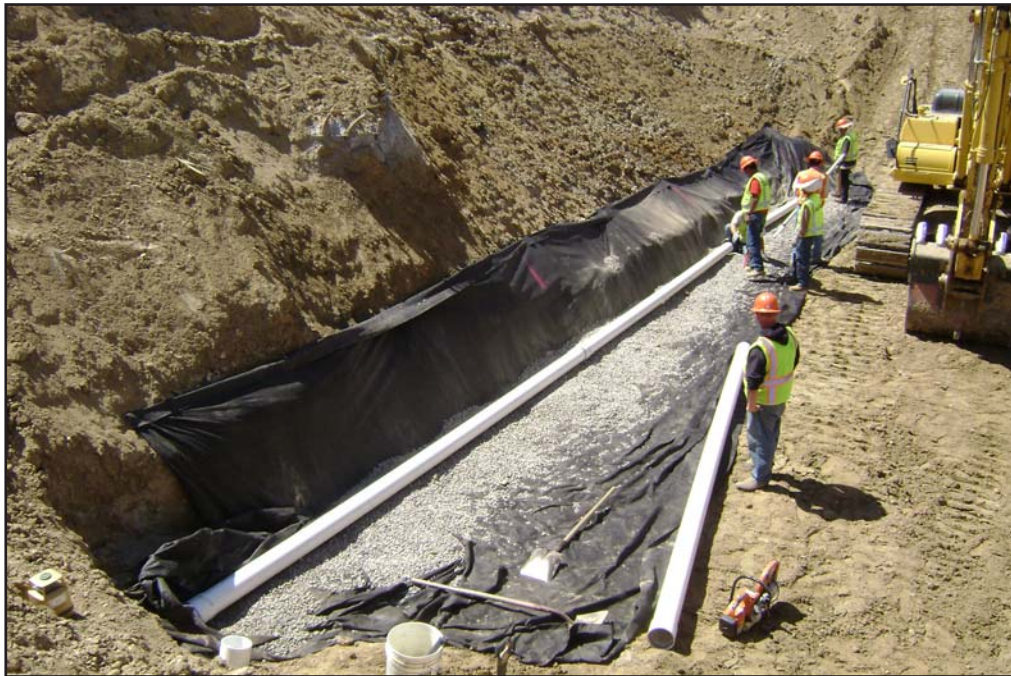
SUBDRAIN CONSTRUCTION AT THE BOTTOM OF SLOT 2

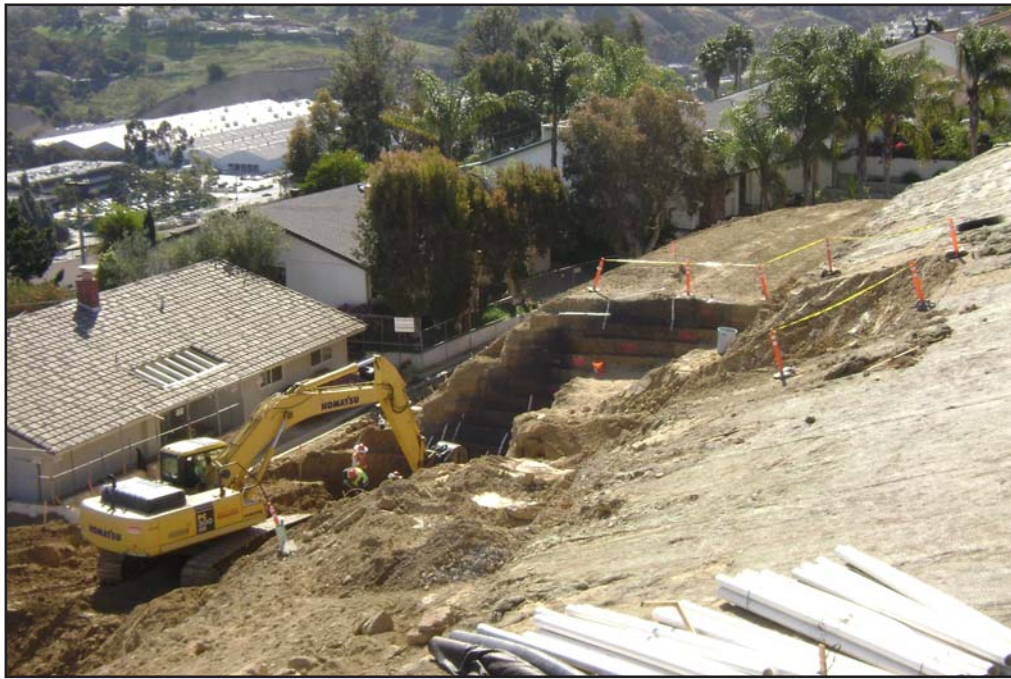
EXCAVATION ACTIVITIES IN SLOT 2

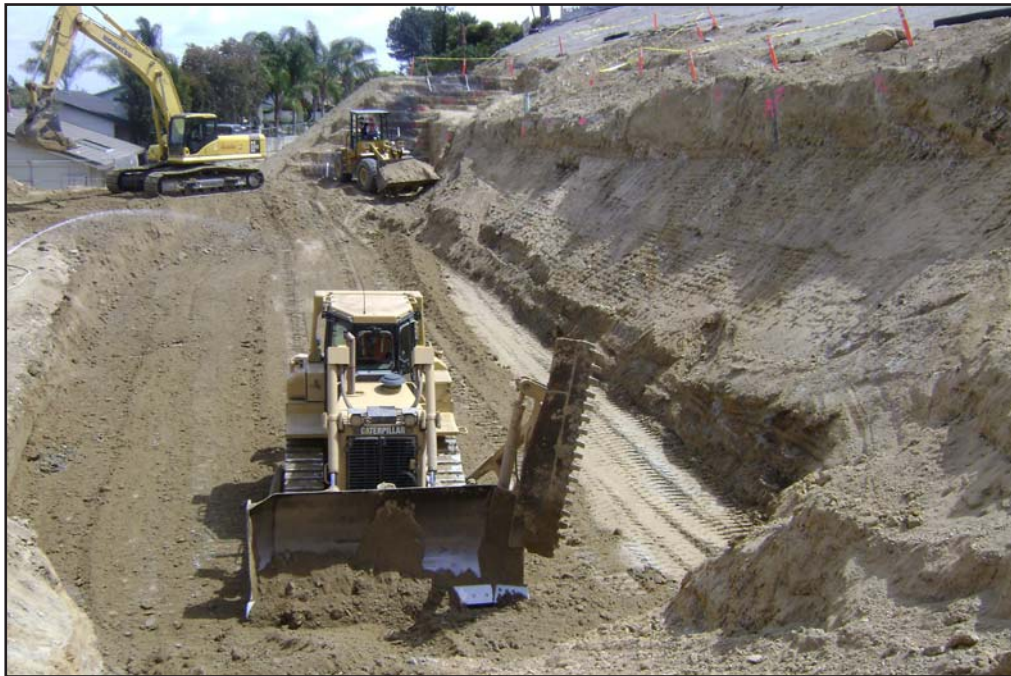
SPREADING OF FILL LIFT IN SLOT 2

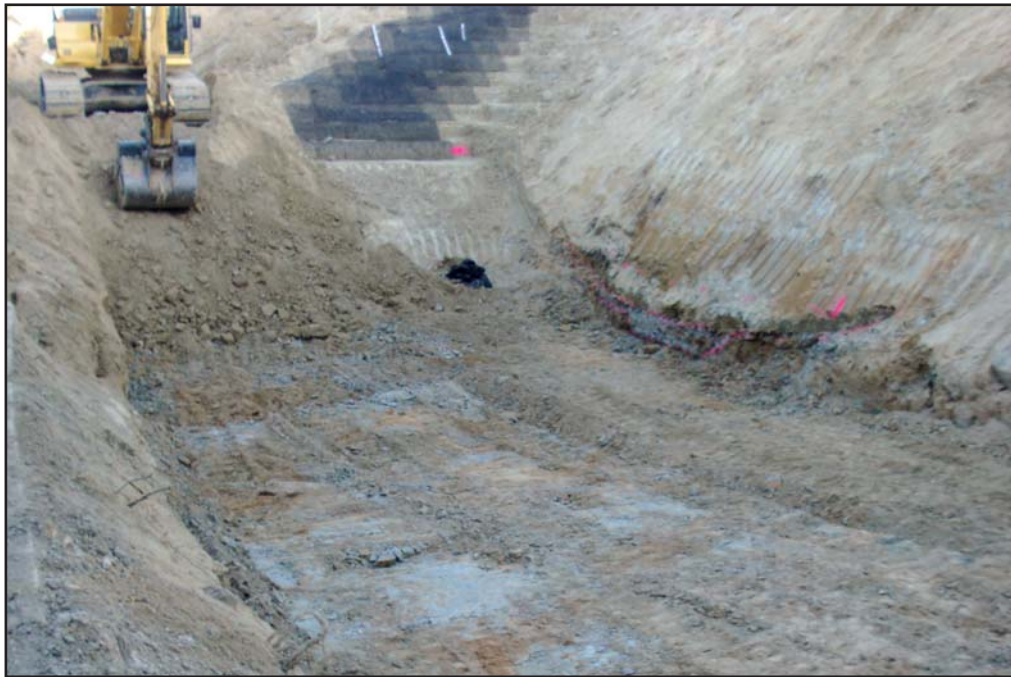
SOUTH END OF SLOT 2 KEYWAY

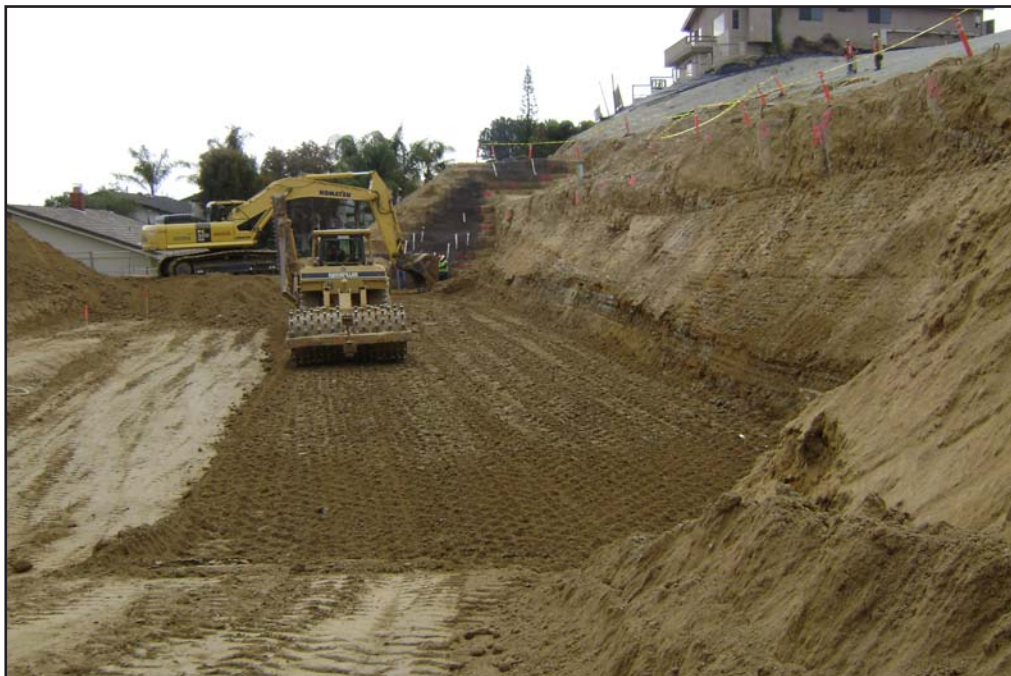
FILL COMPACTION IN SLOT 2 USING SHEEPSFOOT ROLLER PULLED BEHIND A CATERPILLAR D-6R

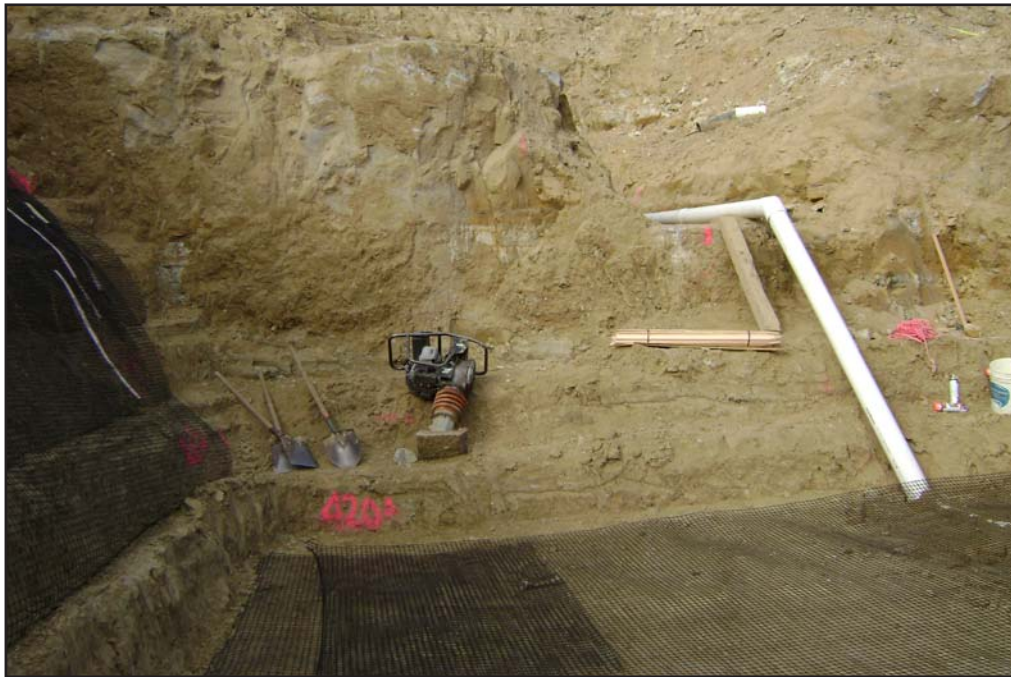
TIGHTLINE CONNECTION FOR SOLEDAD MOUNTAIN ROAD SUBDRAIN OUTLET

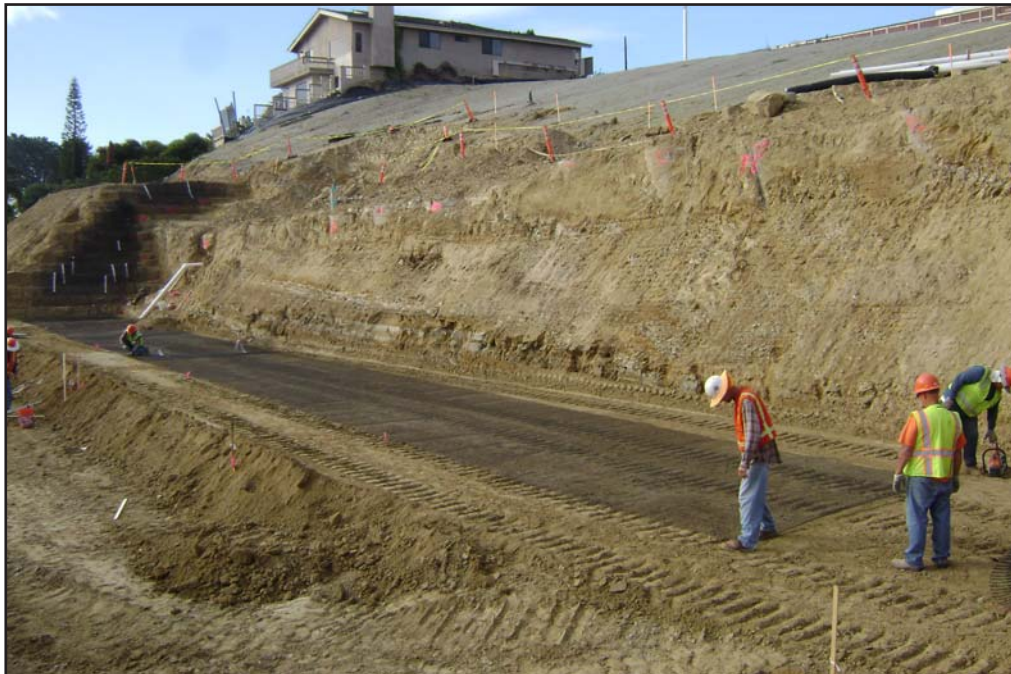
GEOGRID PLACEMENT IN SLOT 2

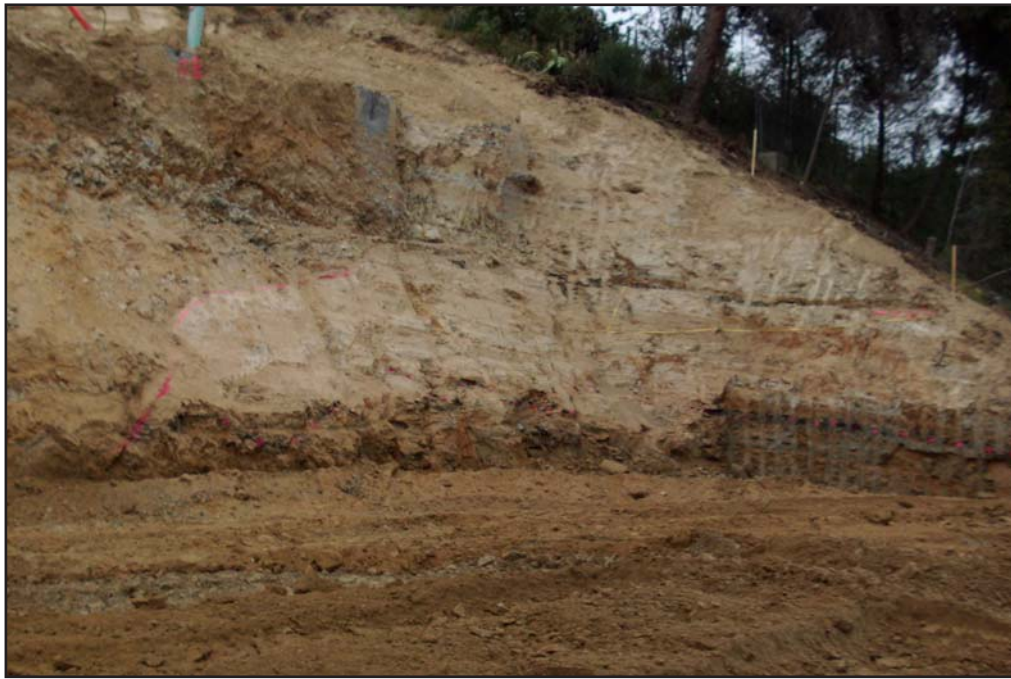
NORTHERN MARGIN OF RECENT LANDSLIDE EXPOSED IN SLOT 1

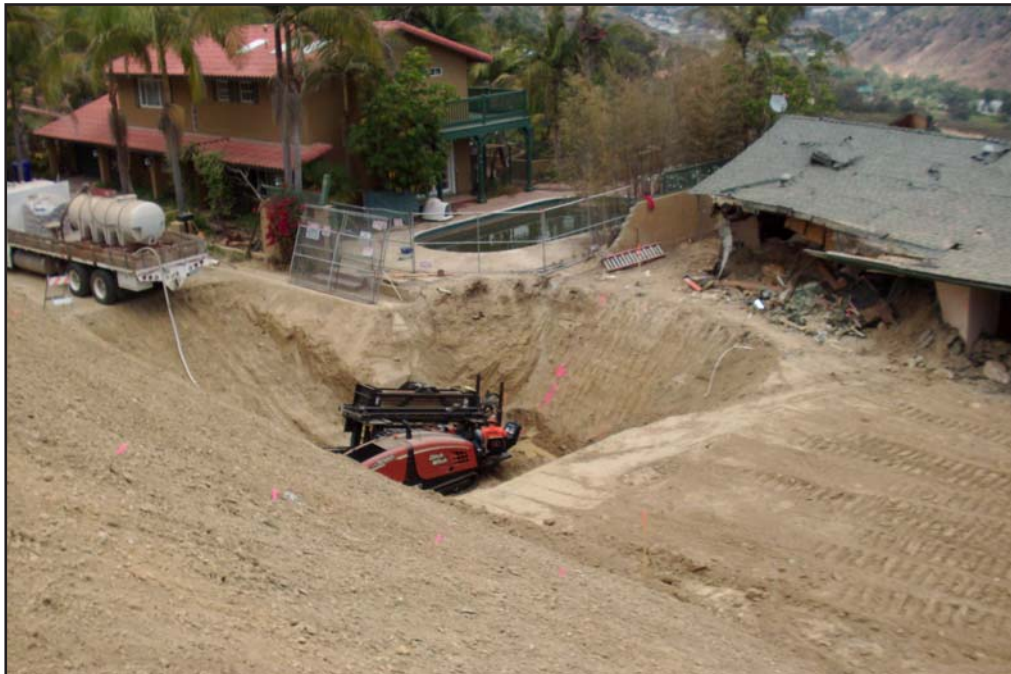
DRILLING OF OUTLET FOR DESERT VIEW DRIVE ALLEY KEYWAY SUBDRAIN

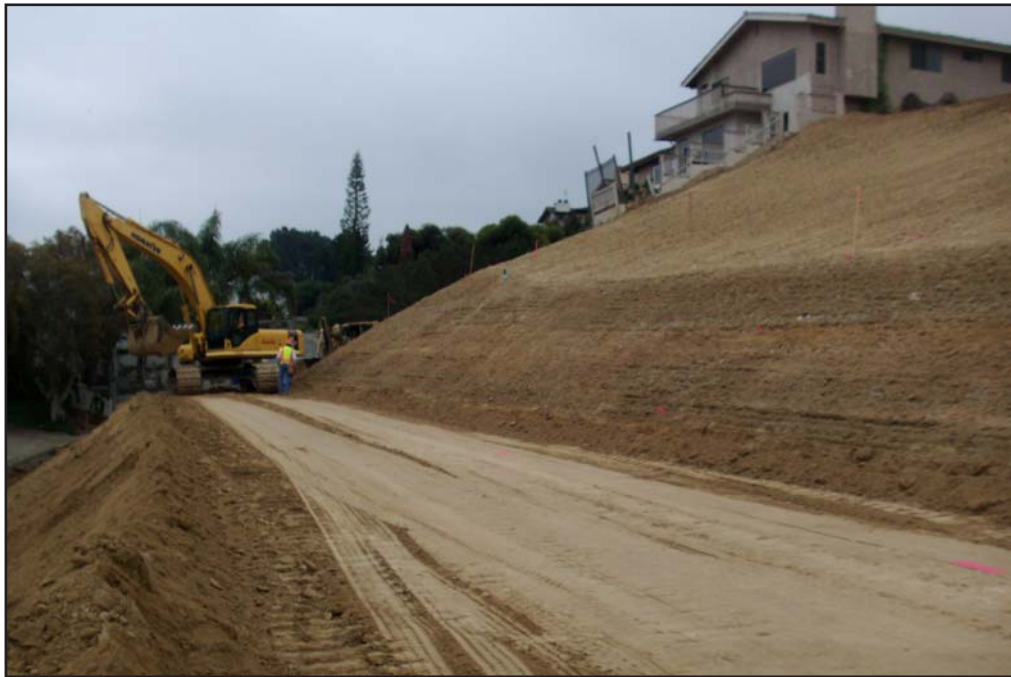
FINISH GRADING OF 1.5:1 (H : V) SLOPE ABOVE DESERT VIEW DRIVE ALLEY

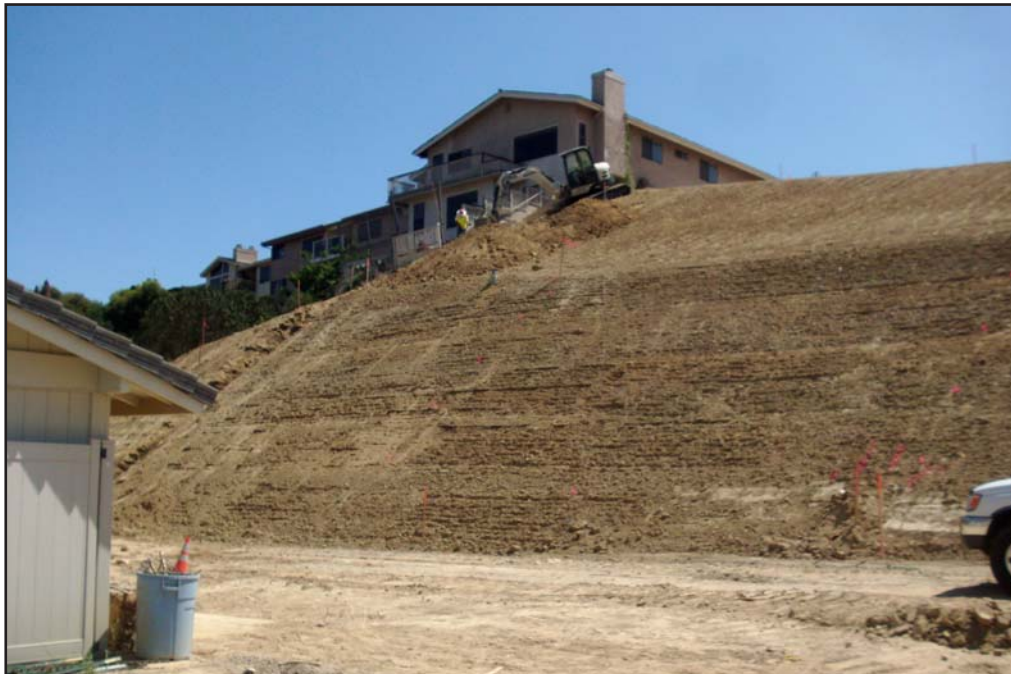
TRENCH EXCAVATION AT SOUTH END OF FINISHED SLOPE FOR 12-INCH, SCH. 40 PVC TIGHTLINE WHICH CONVEYS SURFACE RUNOFF INTERCEPTED BY BROW DITCH TO DESERT VIEW DRIVE ALLEY

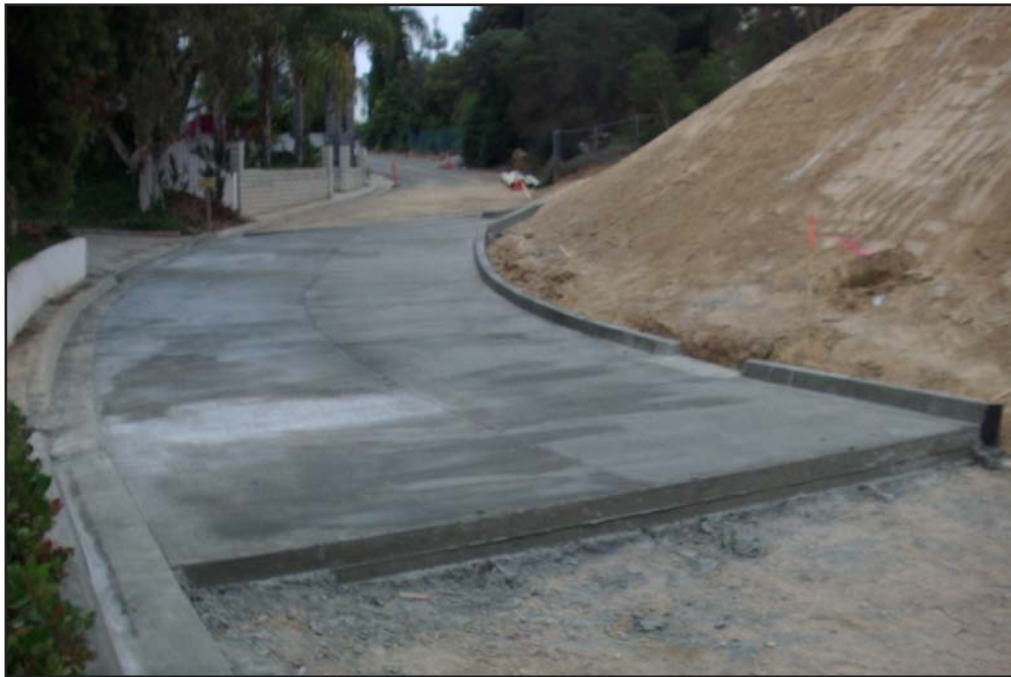
RIGID PAVEMENT DRAINAGE SWALE AT SOUTH END OF DESERT VIEW DRIVE ALLEY

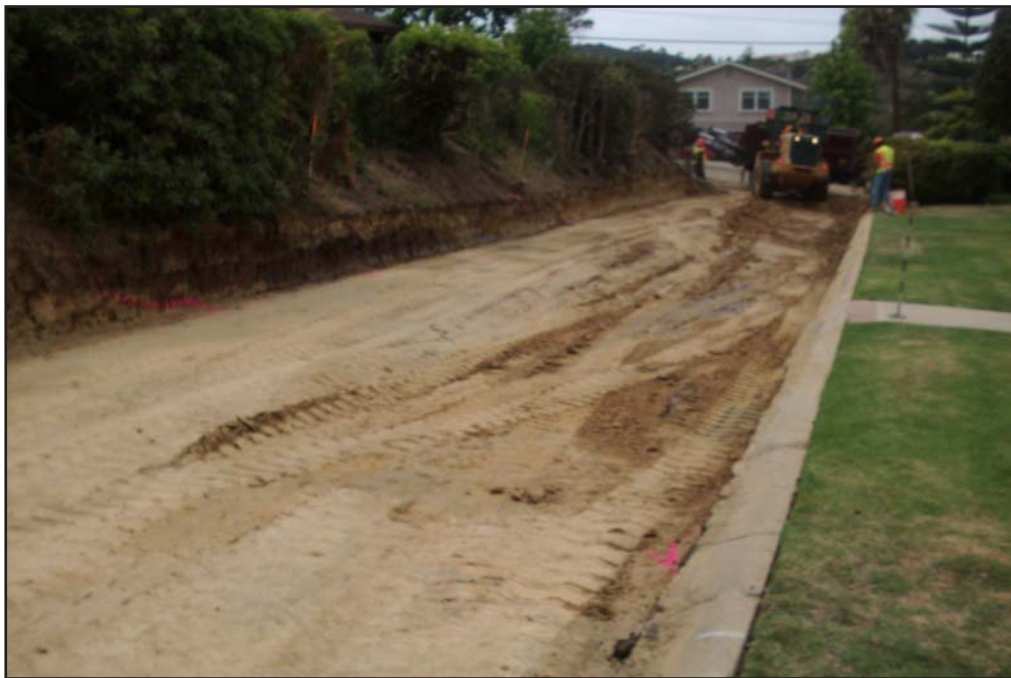
SUBGRADE COMPACTION DURING REPAVING OF DESERT VIEW DRIVE ALLEY
